**Public Hearing
Pinnacle Airlines
Flight 3701
(DCA05MA003)**

Accident Summary

Pinnacle Airlines, CL-600-2B19, Northwest Airlink Flt # 3701, N8396A

NTSB No. DCA05MA003

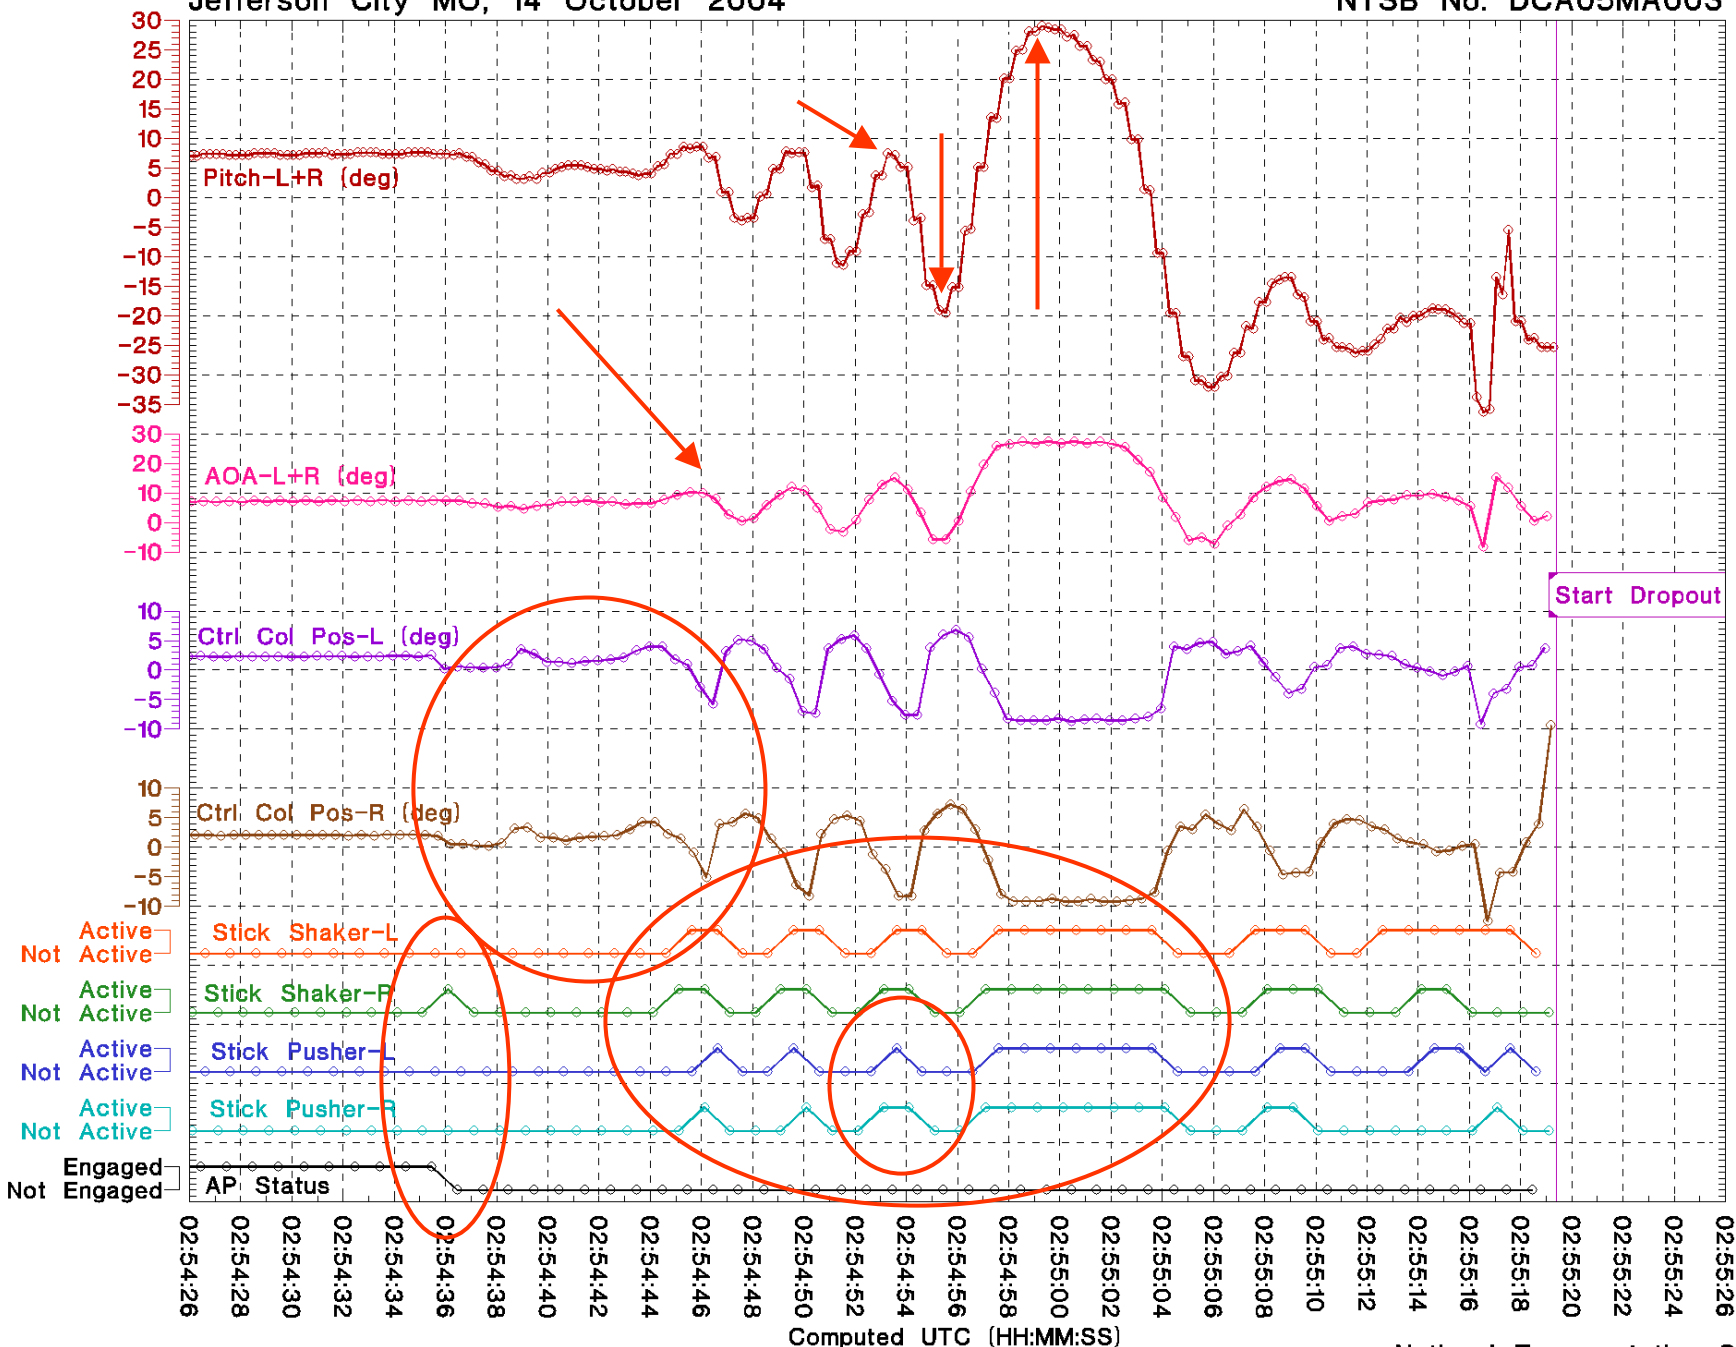
FLG3701 DCA05MA003
Jefferson City, MO
Transcript references
paraphrased; not all
transmissions shown.

FLG3701 We need direct any airport

we're getting a double engine failure

FLG3701 We had an engine failure... in going

in a descent now to start our other engine
